## Surveying the seepage area in the Dong Do dam by the improved multi-electrode electrical exploration method

Chung Anh Do<sup>1,2</sup>, Minh Duc Vu<sup>2,\*</sup>, Luan Thanh Pham<sup>2</sup>, Ahmed M. Eldosouky<sup>3</sup>

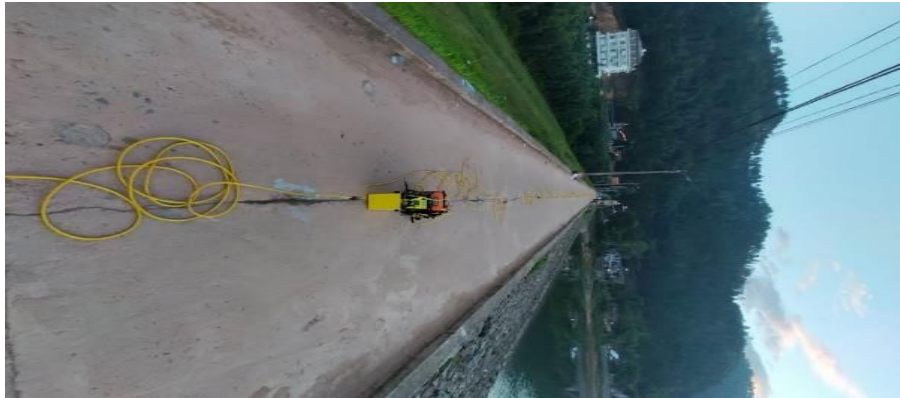
- The dam surface had no subsidence, damage or deterioration, and was assessed to be stable, ensuring

inter-village traffic in Minh Tri commune, as well as stable management and operation of the lake. (Figure 1).

**Figure 1.** Current status at the top surface of the Dong Do dam

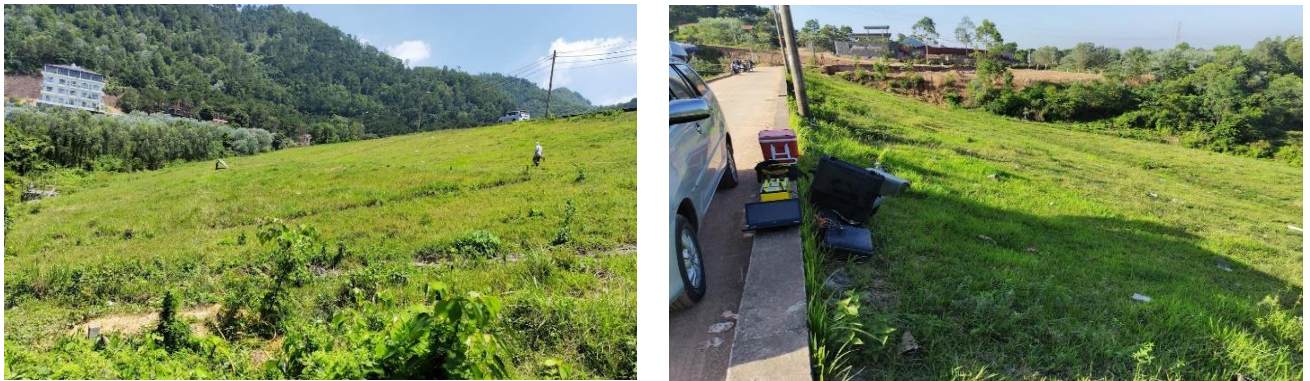
- The downstream dam roof is protected by planting grass beds with vertical grooves along the dam roof located 5m apart, and horizontal grooves running along the dam body, all are made of masonry with a rectangular cross-section sized 0.3x0.3m. The drainage ditch at the foot of the dam was also made of masonry with a trapezoidal cross-section, the width of the bottom is 0.3m, the height of the trench is 0.3m. The current status of the downstream dam roof is stable, there is no subsidence or landslide, ensuring safety. (Figure 2).

**Figure 2.** Current status of the Dong Do downstream dam roof

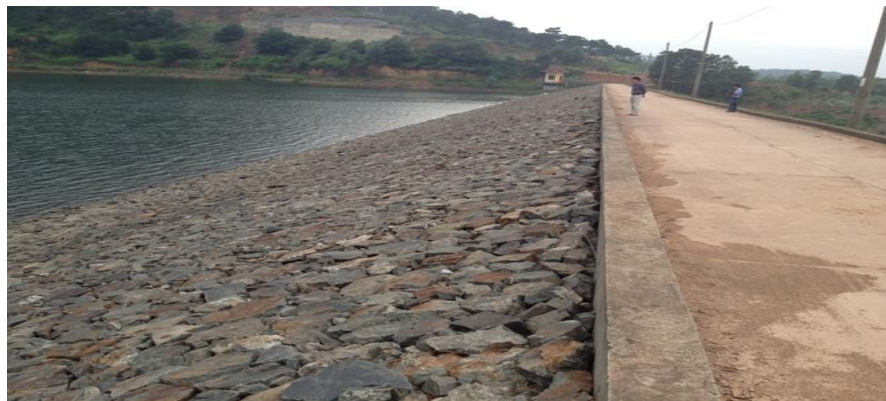
**Figure 3:** Current status of the Dong Do upstream dam roof

- Upstream dam roof is protected by anhydrous paving stones, the footrests of masonry. The current status of the upstream dam roof is stable, with no subsidence or landslide, ensuring safety. (Figure 3)

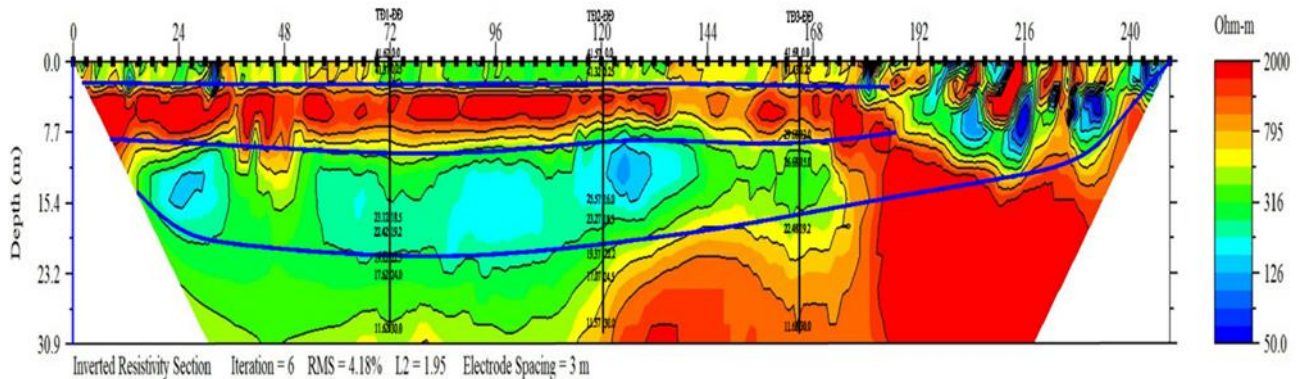
Figure 5. Survey result of the profile along the heartbeat line of the Dong Do dam

The obtained results show that the section from the left shoulder to the 185th meter position in the dam body is made up of 3 layers (Figure 5):

Layer 1: Depth from 0m to 3m, has an average resistivity of 315Ωm.

Layer 2: Depth from 3m to 8.5m, with resistivity greater than 1,000Ωm.

Layer 3: Depth from 8.5m to the deepest point at 23m. In this layer, the resistivity had many fluctuations, specifically: In the passage of the left shoulder with a depth of 8.5m to 18m, from the 18th meter position to the 32nd meter position, and from the 120th meter position to the 130th meter position are two low resistivity anomalies spots with only 50-70Ωm yet located in a layer with resistivity of about 150Ωm. We concluded this could be a seepage

anomaly in the dam. In addition, at the profile on the dam surface, the section from the 185th meter position to the flood spillway (250m) with a depth of 0m to 11m is a large heterogeneous area that needs to be investigated more closely at this location.

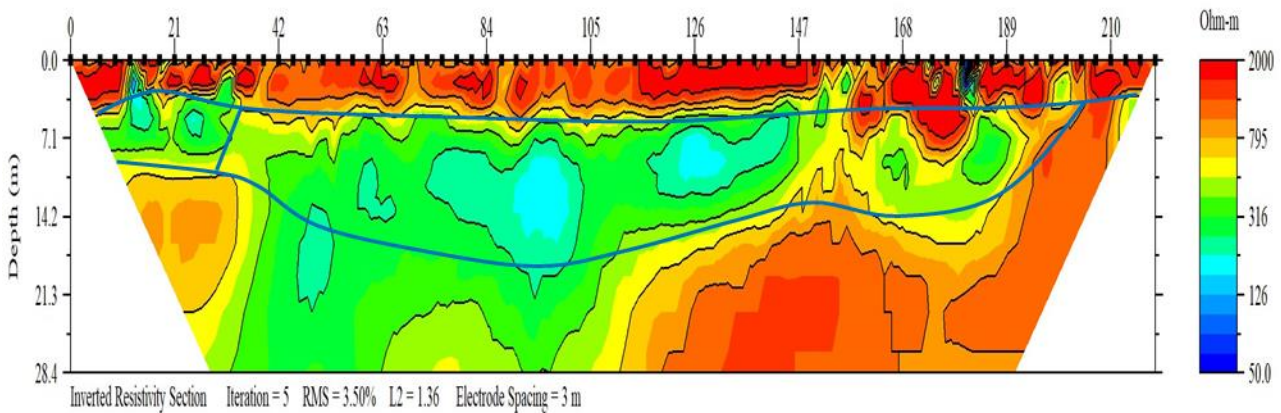
The obtained results from the survey profile in roof 1 shows one less layer of dam composition compared to the profile along the heartbeat line (Figure 6):

Layer 1: Depth from 0m to 6m, has a resistivity greater than 1,000Ωm and extends to the entire survey profile.

Layer 2: Depth from 6m to 15m. Images show that, at this layer, from the beginning of the profile to the 30th meter position at a depth of 3m to 8m, there is a low resistivity anomaly of about 150Ωm yet located in the area with resistivity greater than 800Ωm. This may also be a seepage anomaly for the dam.

**Figure 6.** Survey results of the center profile of roof 1 of the Dong Do dam

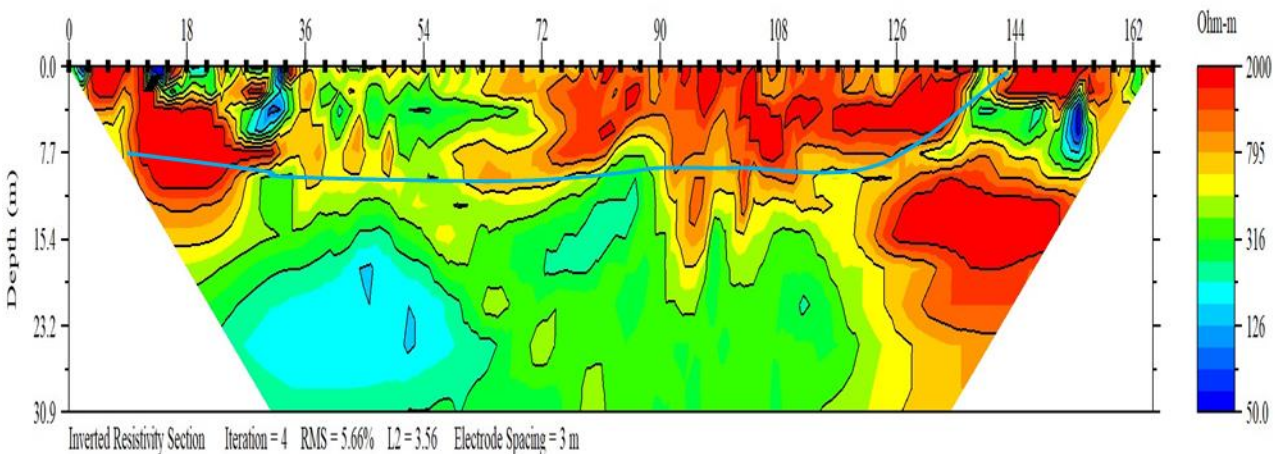
**Figure 7.** Survey results of the center profile of roof 2 of the Dong Do dam

The survey results from the center profile of roof 2 show that there are only 2 layers to distinguish between the embankment and the foundation (Figure 7). The thickness of the embankment is about 8m. In the range from the 12th meter position to the 65th meter position of the survey profile, there is a low resistivity anomaly starting from the surface. According to our assessment, at this location, when lake water level rises, there would be seepage occurring into the dam surface.

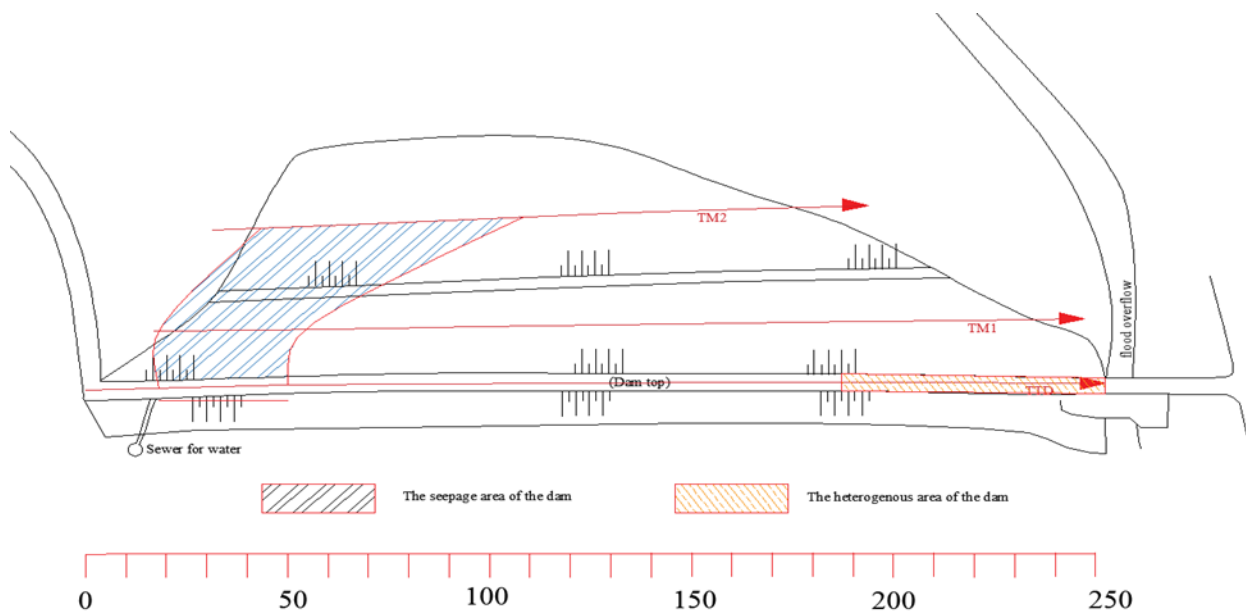
After conducting surveys using the improved multi-electrode electrical exploration method with three profiles at the dam surface, roof 1 and roof 2 downstream, in addition to the comments presented above, the conclusions about the current status of the surveyed dam can be summarized as follows (Figure 8):

- The left shoulder of the dam has a seepage line from upstream to downstream of the dam.
- At the dam surface, close to the flood spillway, there is a heterogenous area that needs to be investigated in more detail.

- The depth of seepage as well as the area are determined with heterogeneity on the survey profiles.

**Figure 8.** Map of the seepage area on the Dong Do dam

It is recommended that related authorities check and monitor the seepage area regularly at the left shoulder of the Dong Do dam and take timely measures if needed. Proceed to carry out detailed surveys of the area near the flood spillway to assess the large heterogeneous anomalies detected.

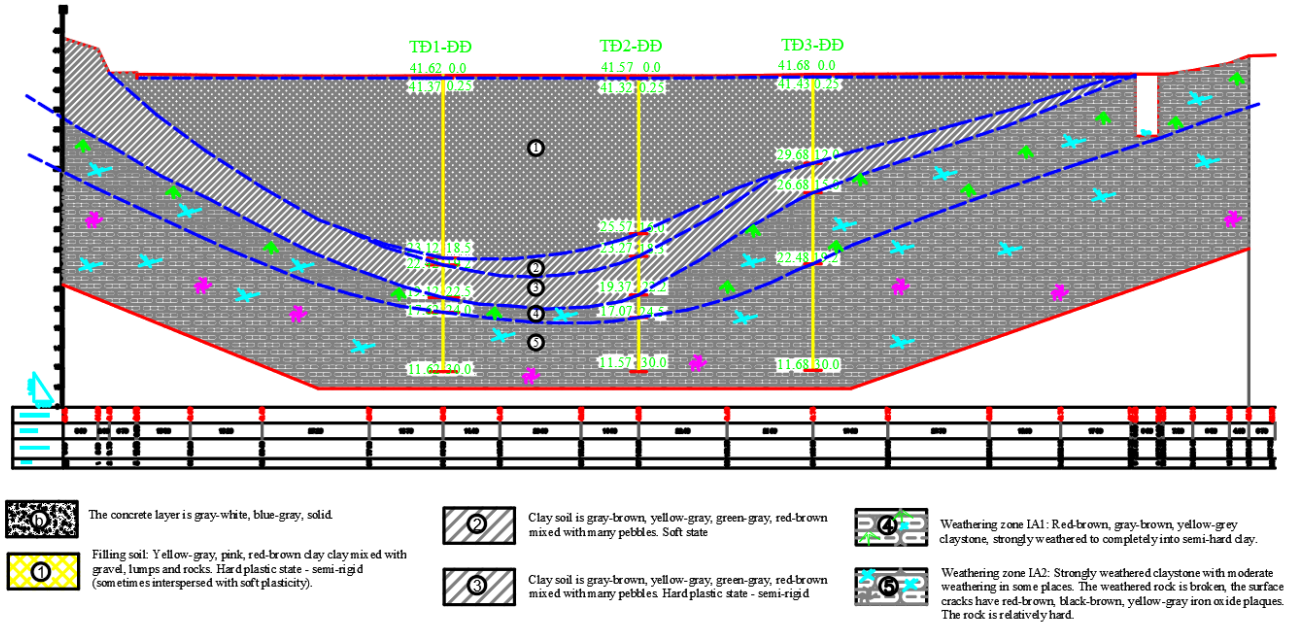
- The geological cross-section is divided into thin layers. The top layer was considered to be homogeneous, yet results from surveys using the improved multi-electrode electrical exploration method discovered that there is a large heterogenous area located near the flood spillway (Figure 12).

Figure 12. Geological cross-section of the profile along the heartbeat line
