## Surveying the seepage area in the Dong Do dam by the improved multi-electrode electrical exploration method

Chung Anh Do<sup>1,2</sup>, Minh Duc Vu<sup>2,\*</sup>, Luan Thanh Pham<sup>2</sup>, Ahmed M. Eldosouky<sup>3</sup>

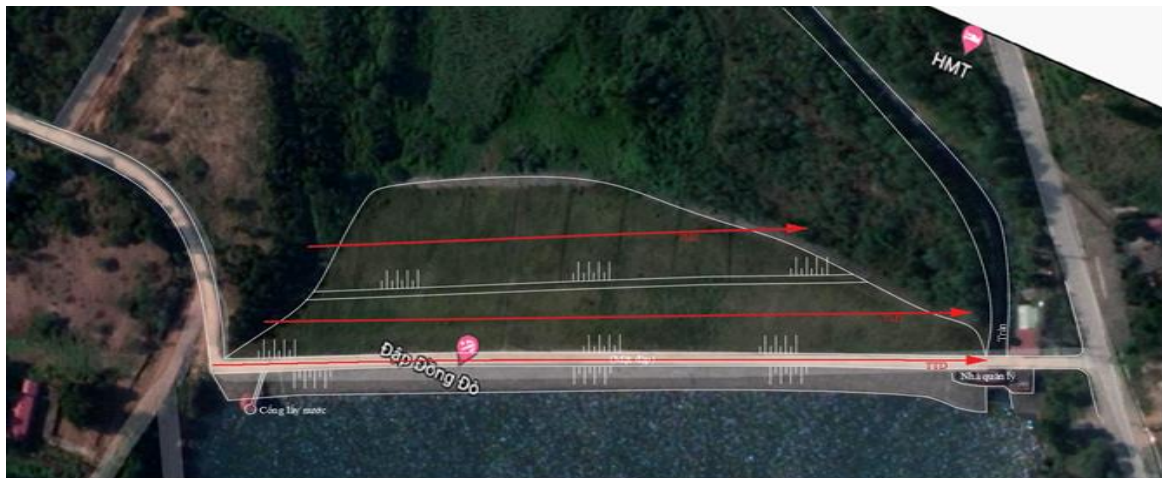
Figure 4. Map of survey profiles for the Dong Do dam

The direction of the measuring profiles is from left shoulder to right shoulder of the dam. The distance between measuring points is 3m. The length of the dam surface profile is 249m. The center profile of roof 1 has a length of 219m and that of roof 2 is 165m. The total survey length is 633m. (Figure 4).

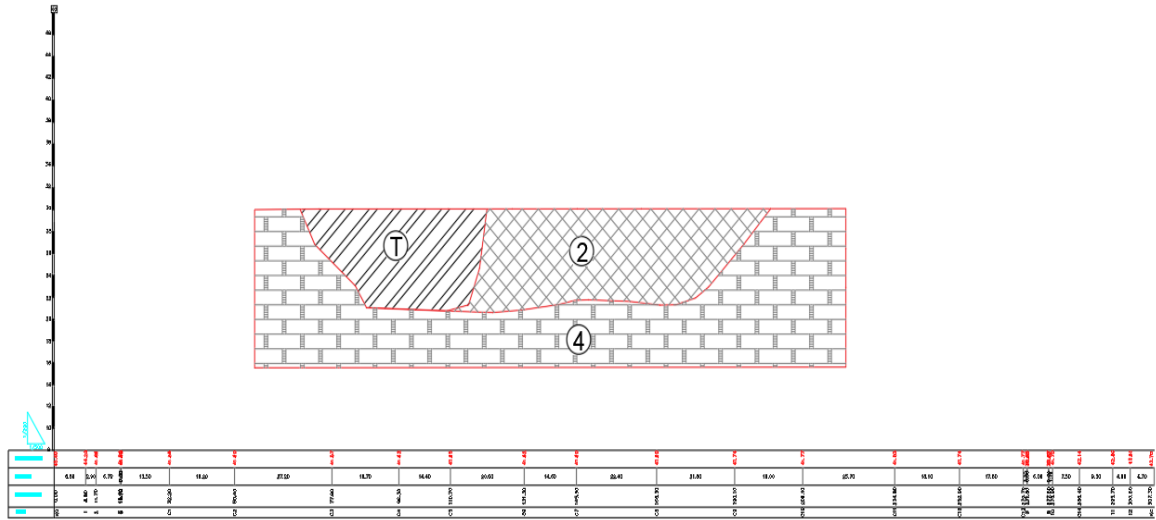
Figure 9. Geological - Geophysical cross section of the center profile of roof 2

The survey results from the center profile of roof 2 show that there are only 2 layers to distinguish between the embankment and the foundation (Figure 7). The thickness of the embankment is about 8m. In the range from the 12th meter position to the 65th meter position of the survey profile, there is a low resistivity anomaly starting from the surface. According to our assessment, at this location, when lake water level rises, there would be seepage occurring into the dam surface.

According to the results of 3 boreholes on the profile along the heartbeat line of the dam and the Geological cross-sections [9], we have linked the survey results using the improved multi-electrode electrical exploration method and the drilling and geology documents into Geological - Geophysical cross-sections. These cross-sections are shown in Figures 8, 9, 10 and 11.

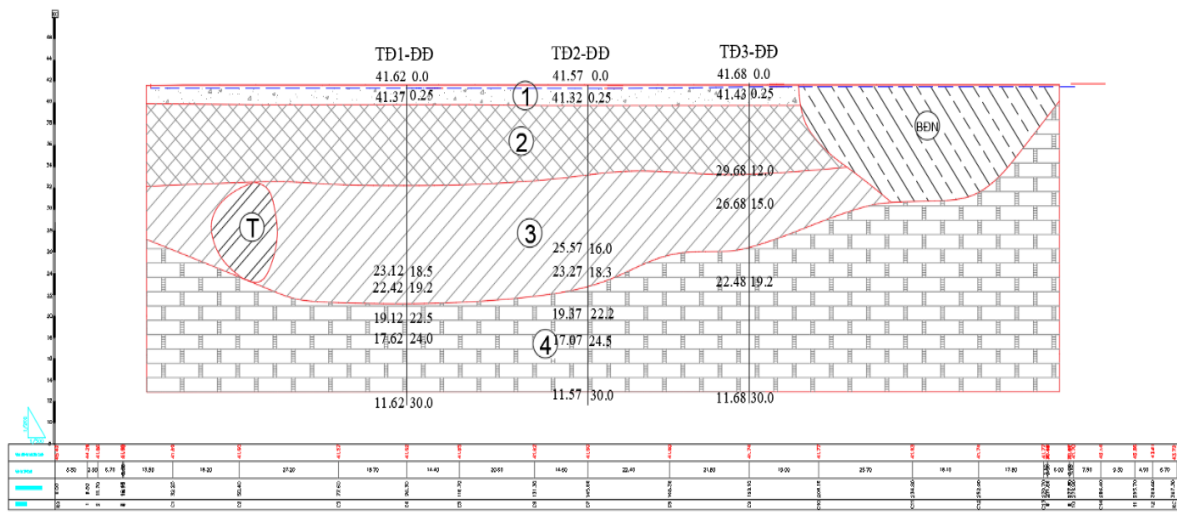
Figure 11. Geological - Geophysical cross section of the profile along the heartbeat line

The obtained results show that the section from the left shoulder to the 185th meter position in the dam body is made up of 3 layers (Figure 5):

Layer 1: Depth from 0m to 3m, has an average resistivity of 315Ωm.

Layer 2: Depth from 3m to 8.5m, with resistivity greater than 1,000Ωm.

It is recommended that related authorities check and monitor the seepage area regularly at the left shoulder of the Dong Do dam and take timely measures if needed. Proceed to carry out detailed surveys of the area near the flood spillway to assess the large heterogeneous anomalies detected.
